# Villa San Marco Condominium Association, Inc.

Inspected: December 4, 2024 • Revised on: February 27, 2025  
St. Augustine, FL

STRUCTURAL INTEGRITY  
RESERVE STUDY

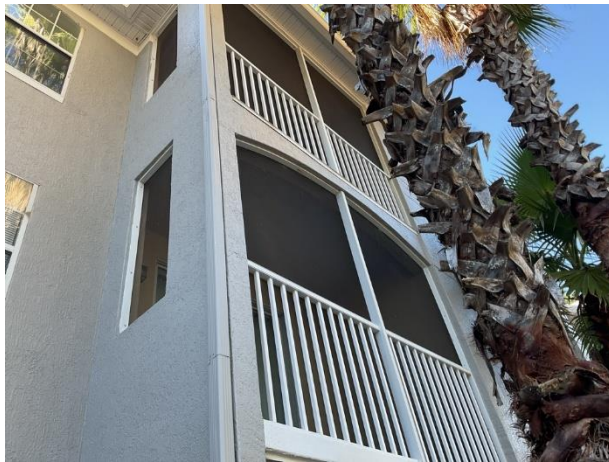
**Condition:** The breezeways are in good overall condition and the balconies are in good to fair overall condition. We note the following for the balconies:

Balconies with concrete surfaces

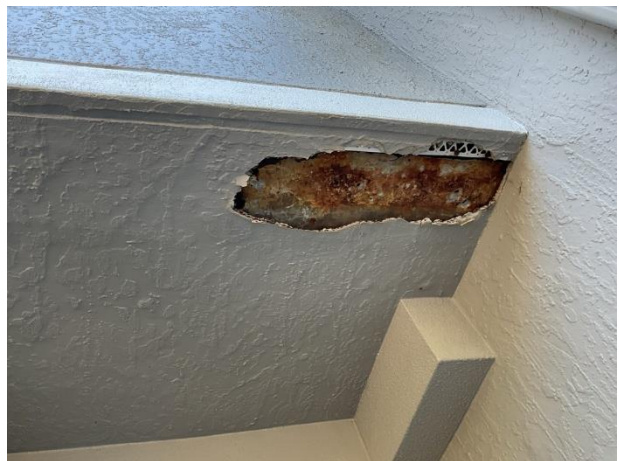
- The coating is in good to fair condition. There is isolated exposed rust evident
- Isolated evidence of water infiltration is evident

Evidence of water infiltration

**Useful Life:** Capital repairs including a close-up visual inspection, patching of delaminated concrete, routing and filling of cracked concrete, and waterproof coating applications every 20- to 25-years.

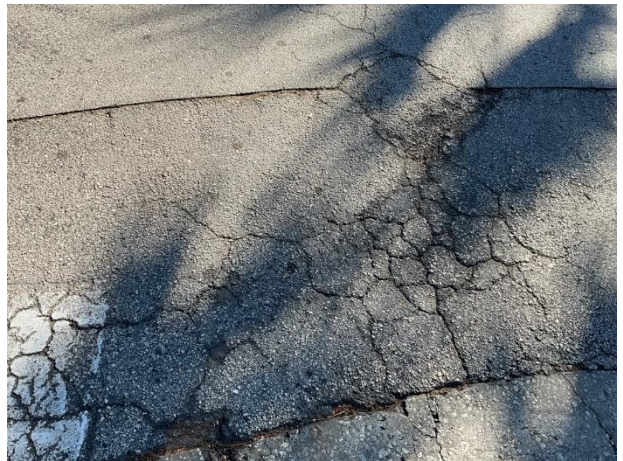
**Condition:** Fair overall with isolated cracks and previous repairs evident.

**Pavement cracks**

application of two or more new lifts of asphalt. We recommend mill and overlayment on asphalt pavement that exhibits normal deterioration and wear. We recommend total replacement of asphalt pavement that exhibits severe deterioration, inadequate drainage, pavement that has been overlaid multiple times in the past or where the configuration makes overlayment not possible. Based on the apparent visual condition and configuration of the asphalt pavement, we recommend the mill and overlay method of repaving at Villa San Marco.

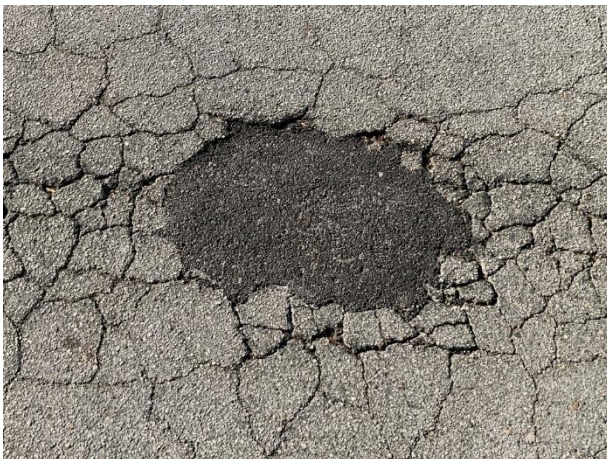
**Pavement deterioration**

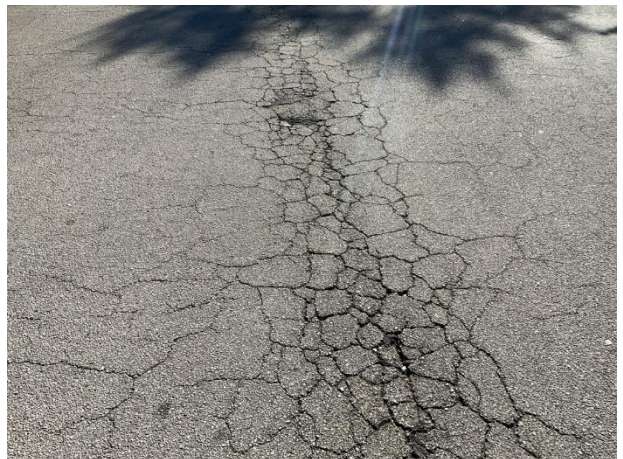
**Pavement cracks**

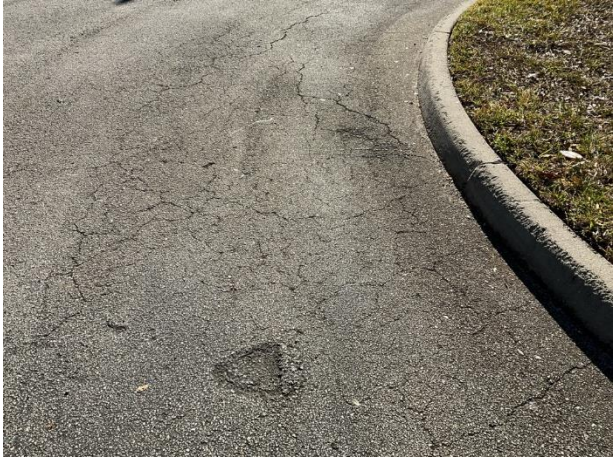
**Pavement cracks**

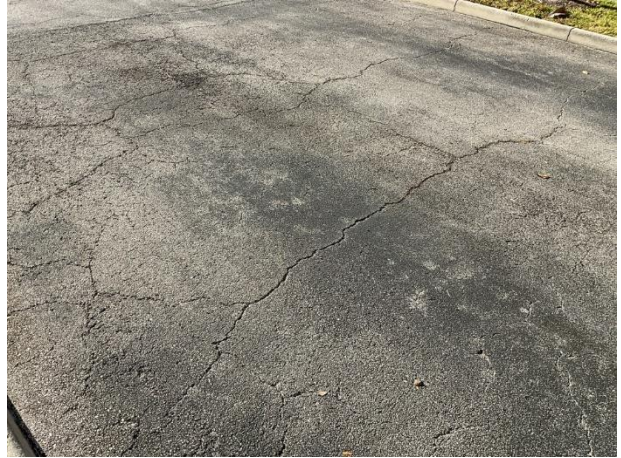
**Pavement cracks**

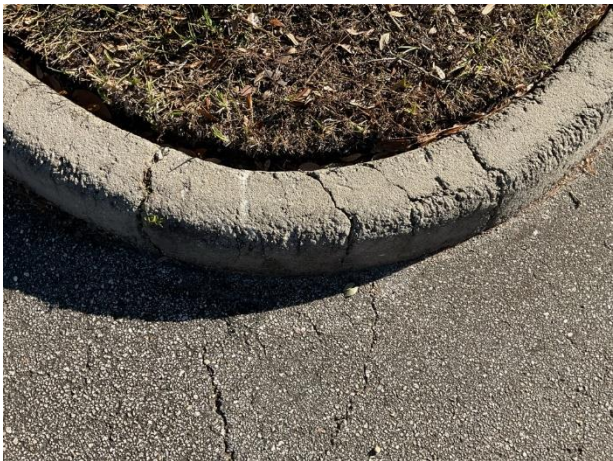
**Condition:** Fair to poor overall with cracks evident.

**Concrete cracks**

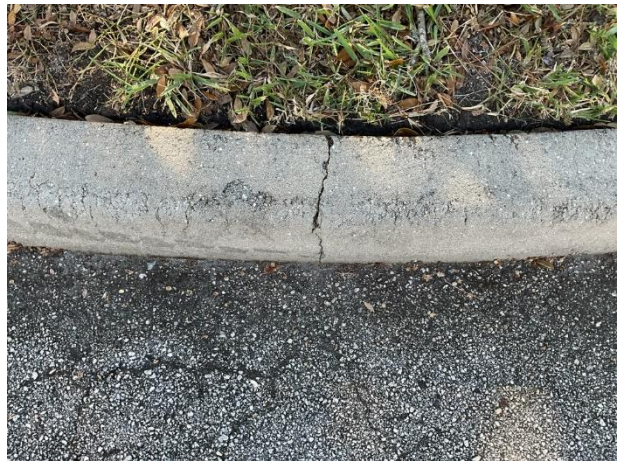
**Concrete cracks**

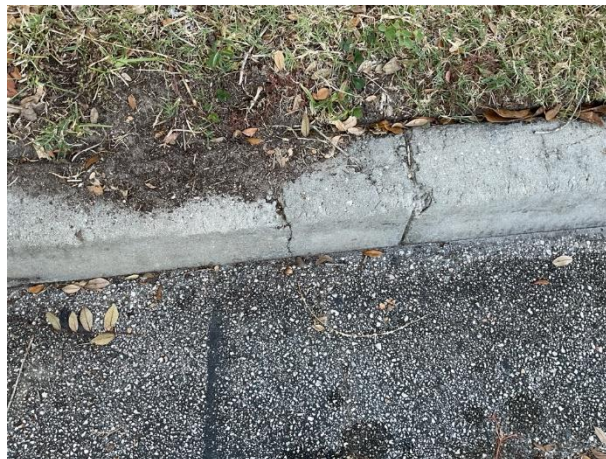
**Concrete cracks**

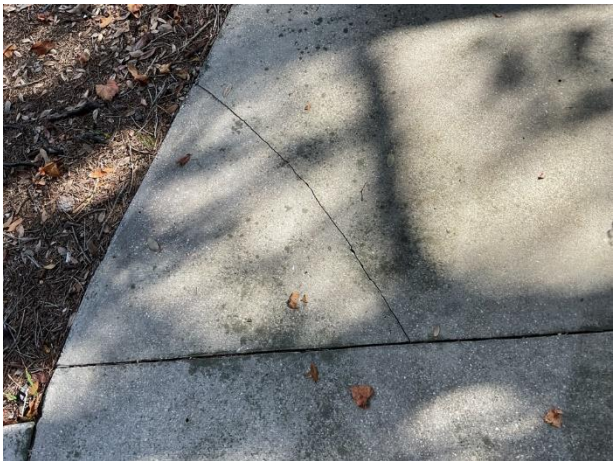
**Condition:** Fair overall with isolated cracks evident.

**Sidewalk cracks**

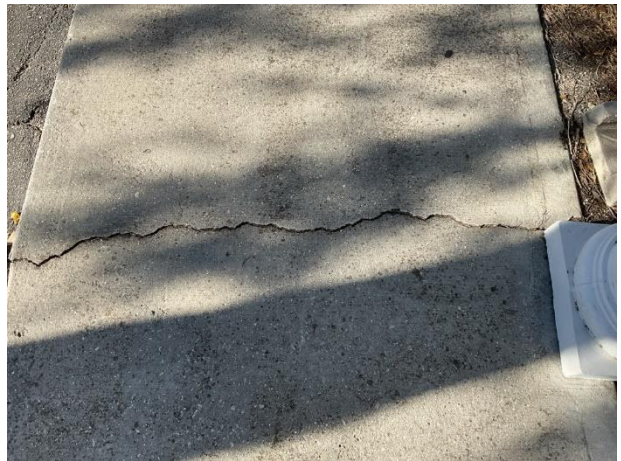
**Sidewalk cracks**

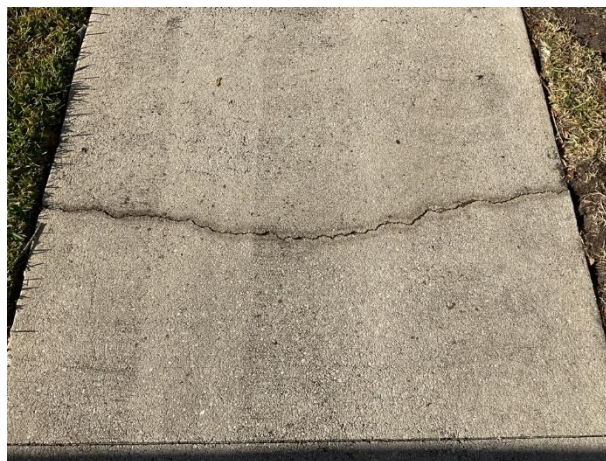
**Sidewalk cracks**

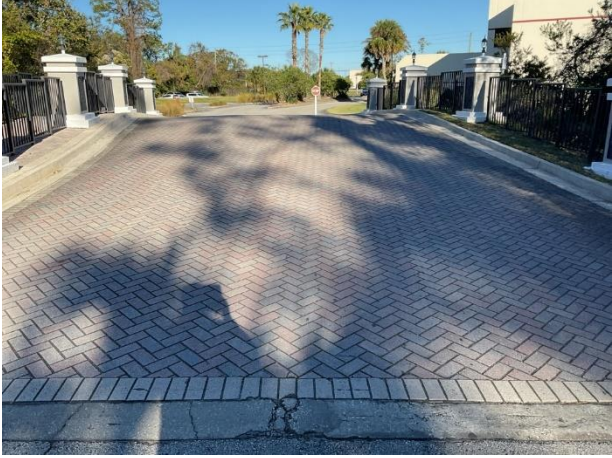
**Condition:** Good to fair overall with isolated spalled masonry evident.

**Pavers overview**

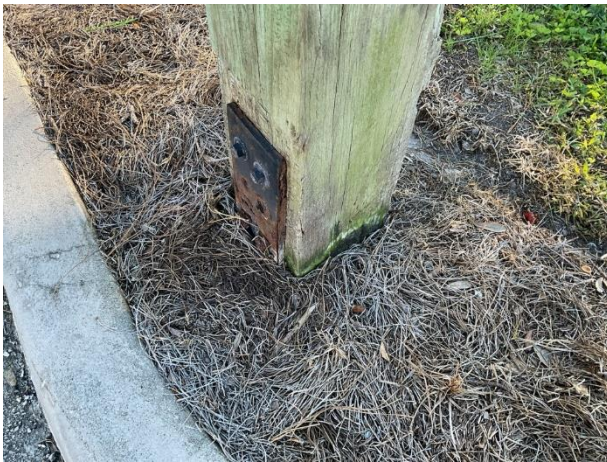
**Condition:** Fair overall with isolated wood deterioration evident

**Pergola wood deterioration**

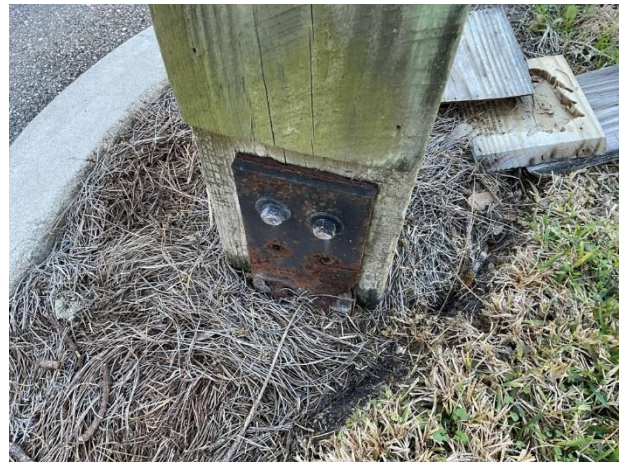
**Pergola wood deterioration**

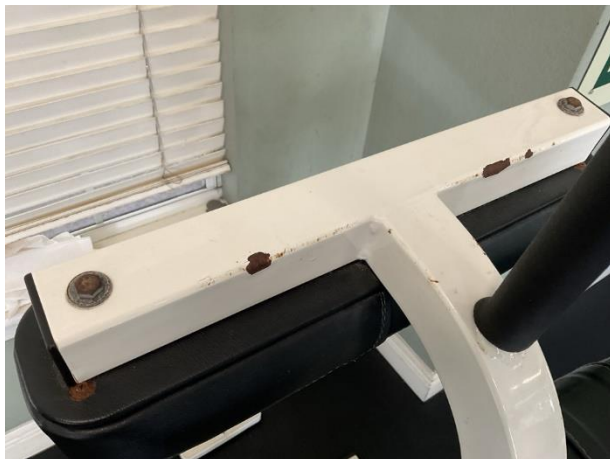
**Conditions:** Fair overall with isolated rust evident.

**Strength training exercise equipment rust**

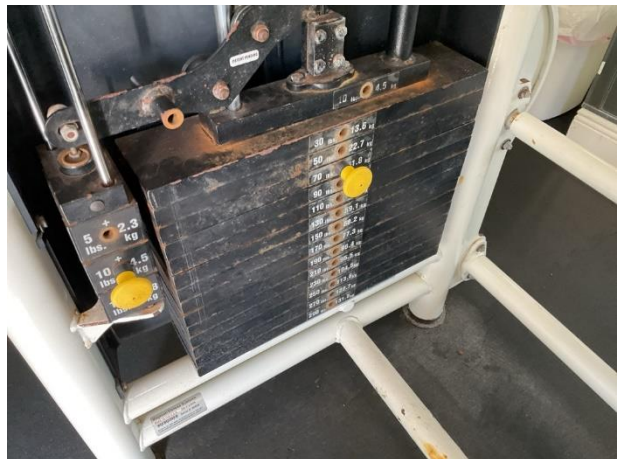
**Strength training exercise equipment rust**

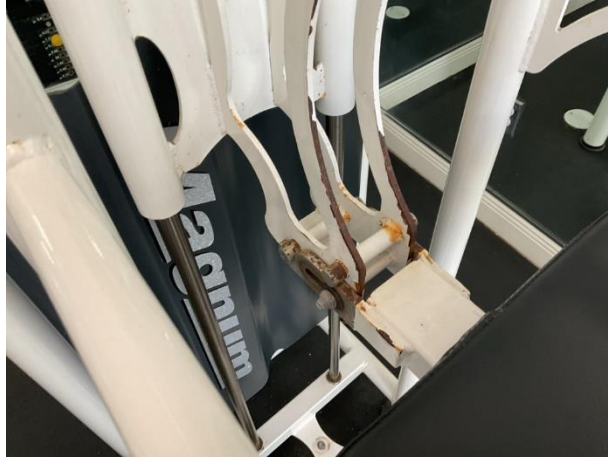
**Strength training exercise equipment rust**

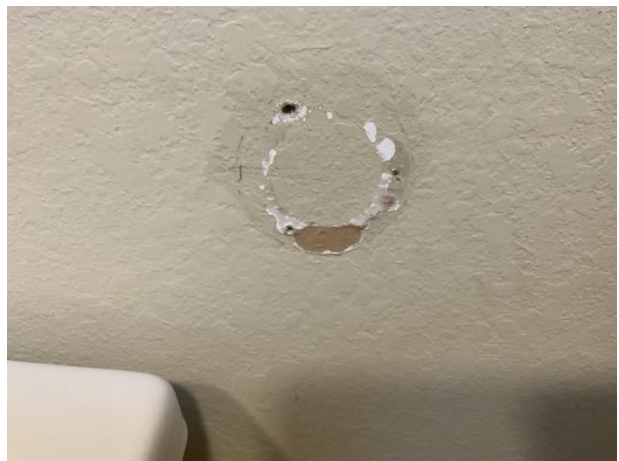
**Condition:** Fair overall with no isolated wall damage and floor previous repairs evident.

Rest room wall damage

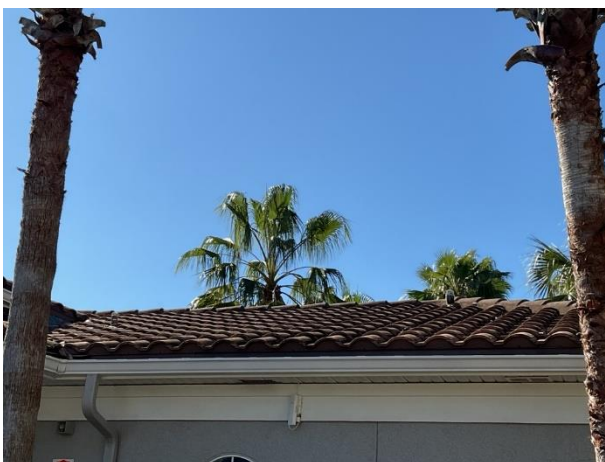
**Condition:** Good to fair overall with isolated weathered tiles evident from our visual inspection from the ground. Management does not report a history of leaks.

**Concrete tile roofs overview**

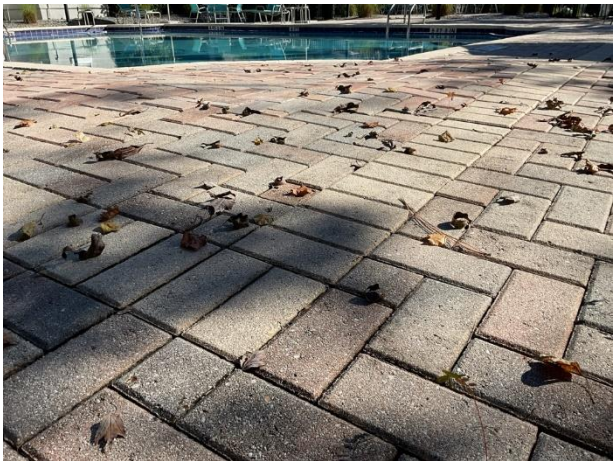
**Condition:** Poor overall with isolated trip hazards evident.

**Trip hazard**

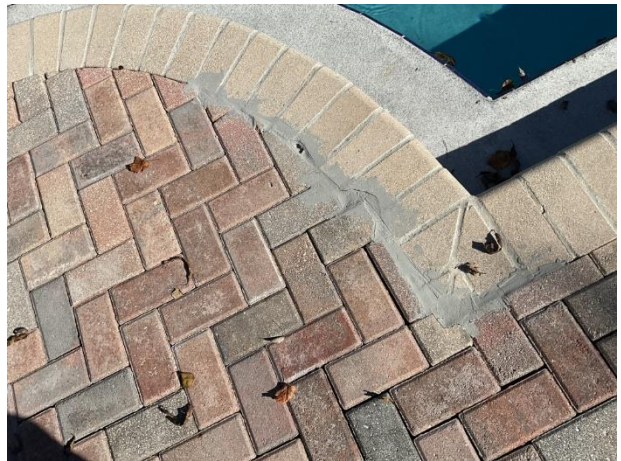
**Paver pool deck previous repairs**

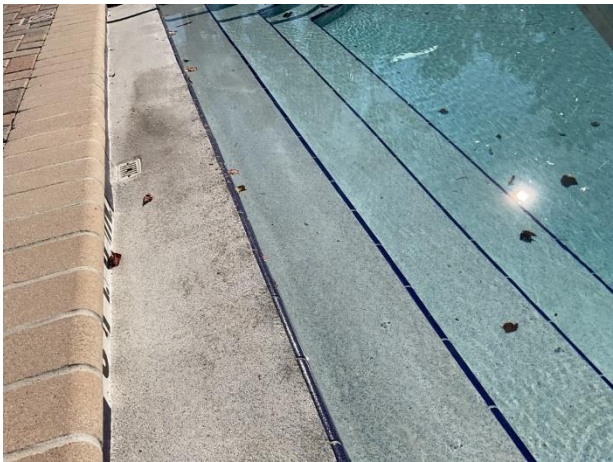
**Condition:** Fair overall with isolated plaster discoloration evident

Pool plaster finish with tile perimeter
