# Villa San Marco Condominium Association, Inc.

Inspected: December 4, 2024 • Revised on: February 27, 2025  
St. Augustine, FL

STRUCTURAL INTEGRITY  
RESERVE STUDY

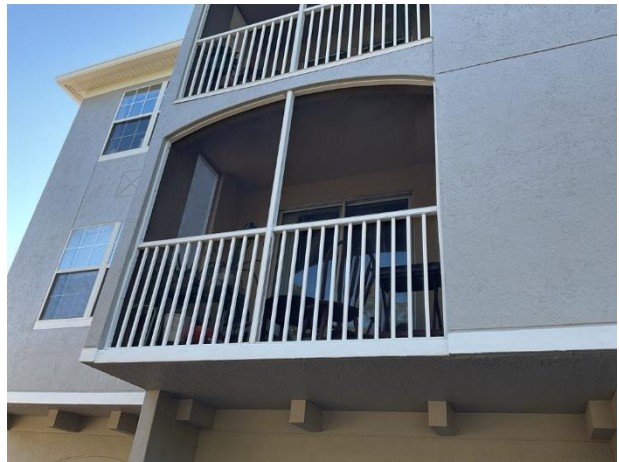
Balconies with concrete surfaces

**Useful Life:** Capital repairs including a close-up visual inspection, patching of delaminated concrete, routing and filling of cracked concrete, and waterproof coating applications every 20- to 25-years.

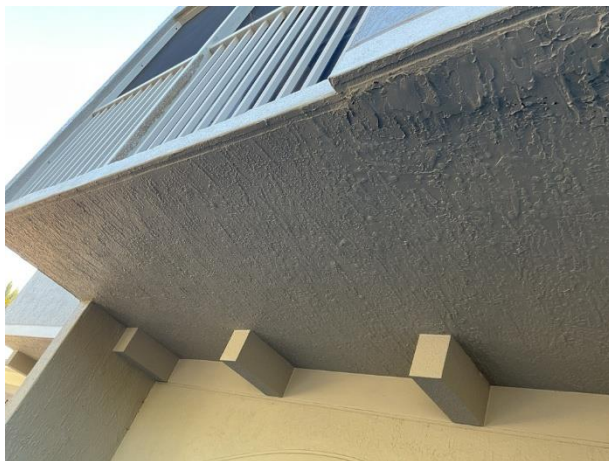
Underside of concrete balcony

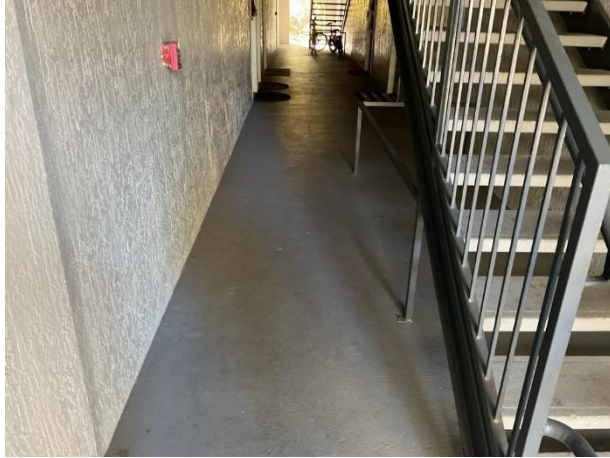
**Breezeway overview**

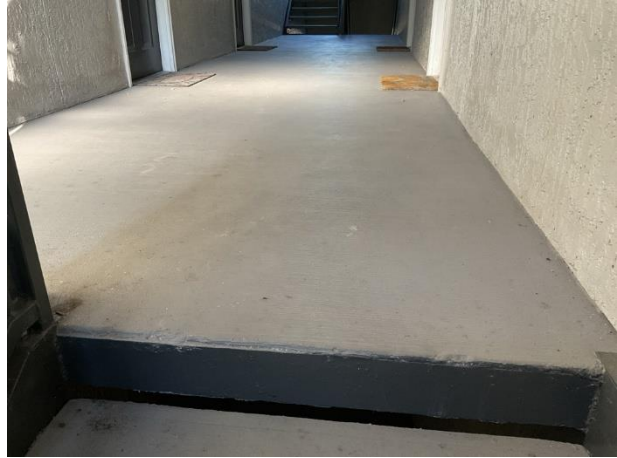
**Breezeway overview**

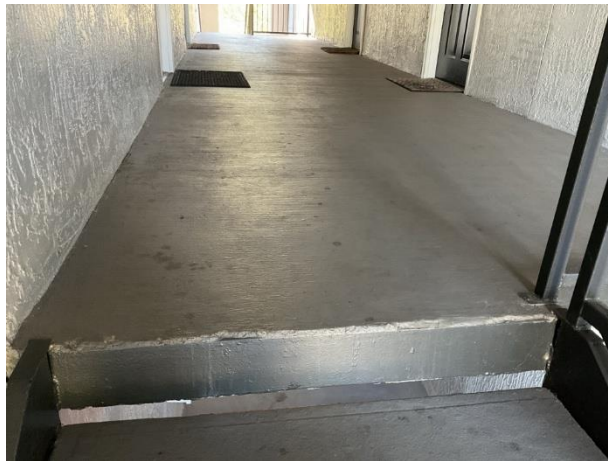
**Breezeway overview**

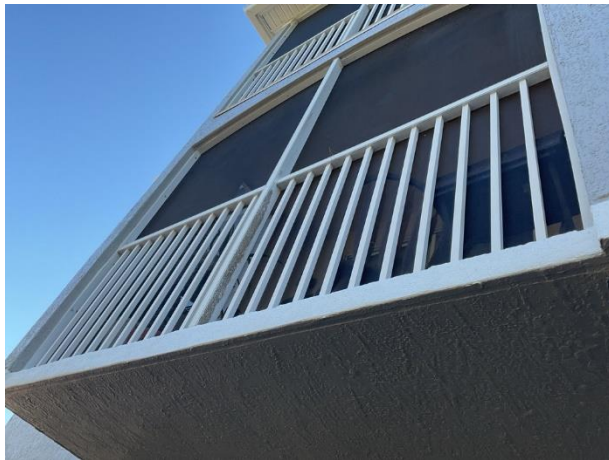
**Conditions:** The railings finishes are in good overall condition

**Balcony aluminum railings**

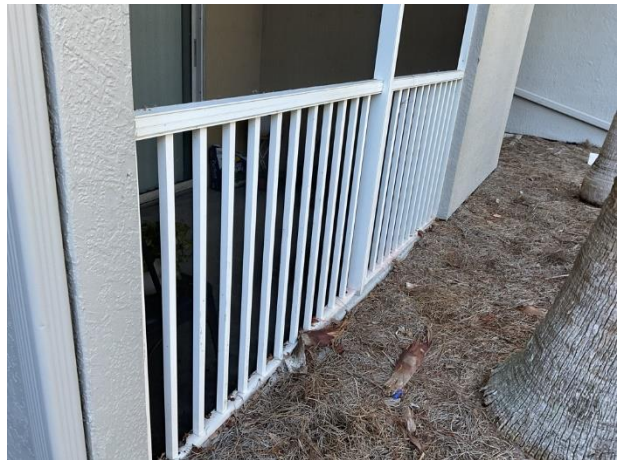
**Patio aluminum railings**

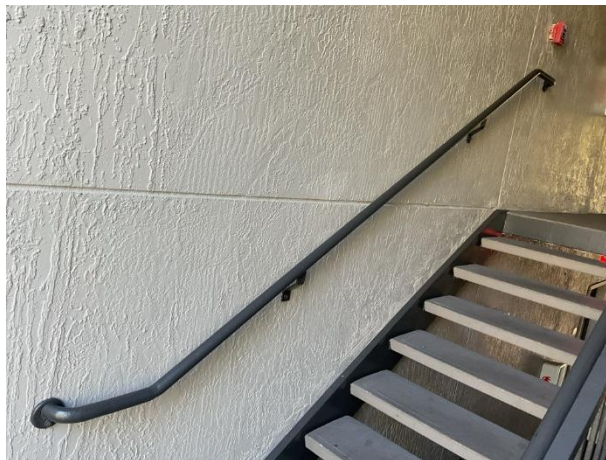
**Conditions:** The railings are in good overall condition and the railing finishes are in good condition with no visible deterioration

**Breezeway railing**

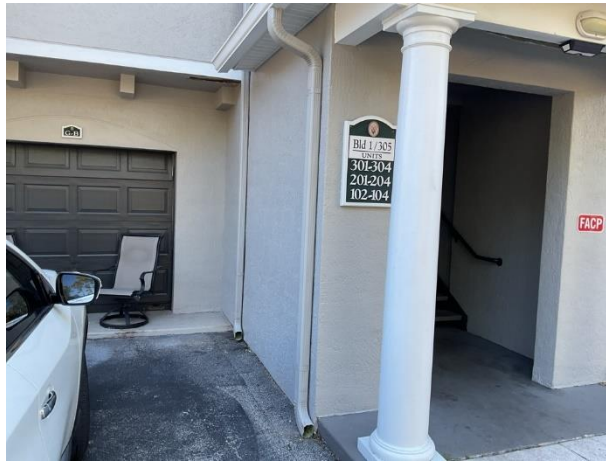
**Condition:** Good overall with no visible deterioration

**Aluminum gutters and downspouts**

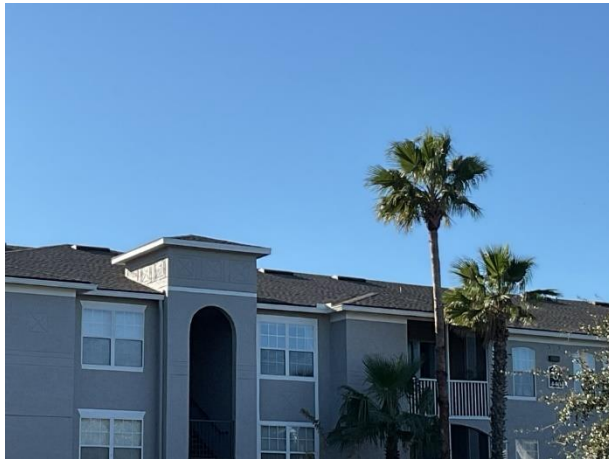
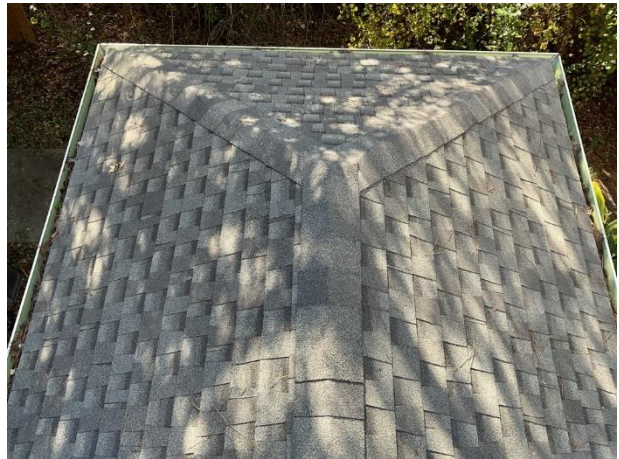
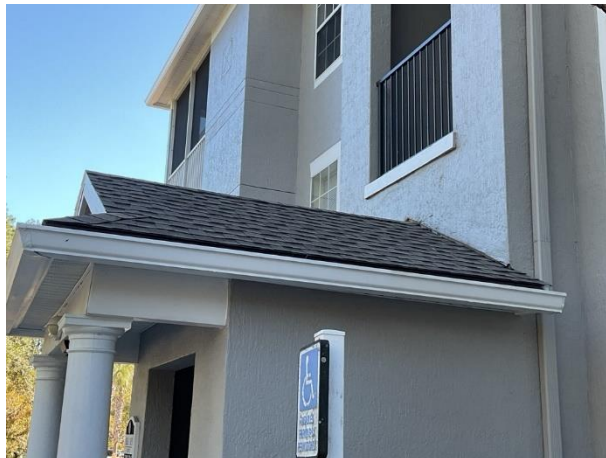
**Condition:** Good overall with no significant deterioration evident from our visual inspection from the ground. Management does not report a history of leaks.

Roof overview

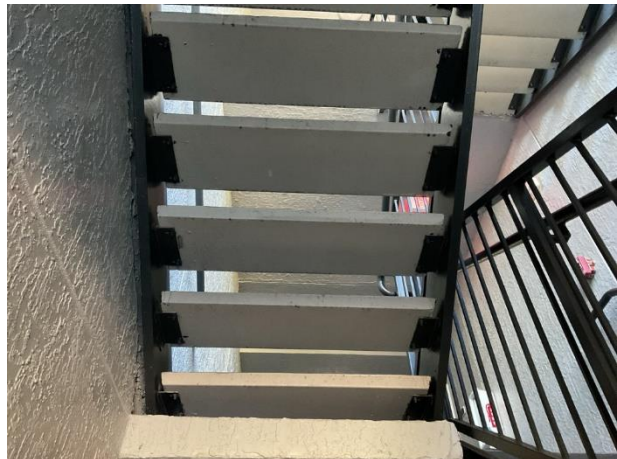
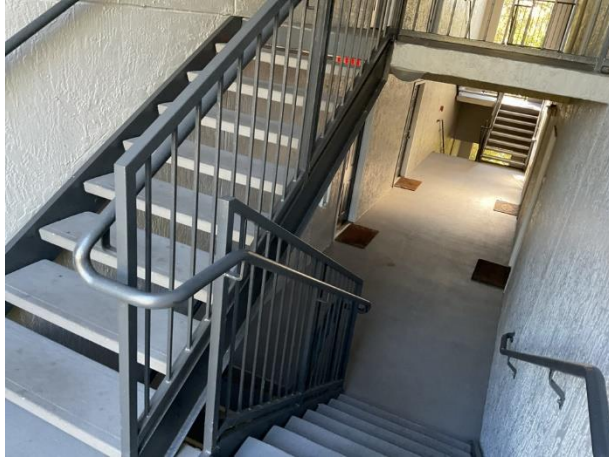
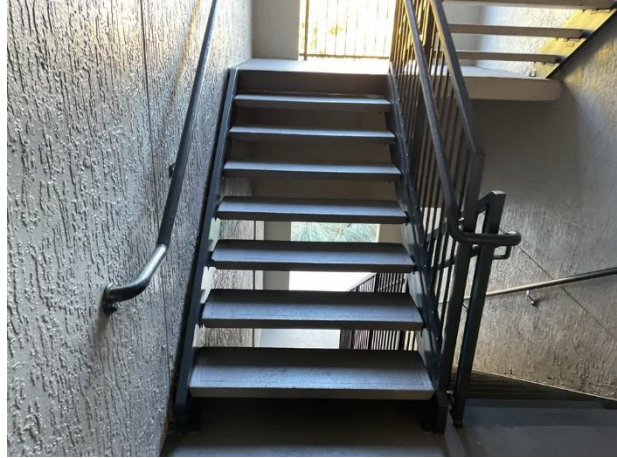
**Condition:** Good overall with no significant deterioration evident.

**Staircase overview**

**Metal staircase with concrete treads**

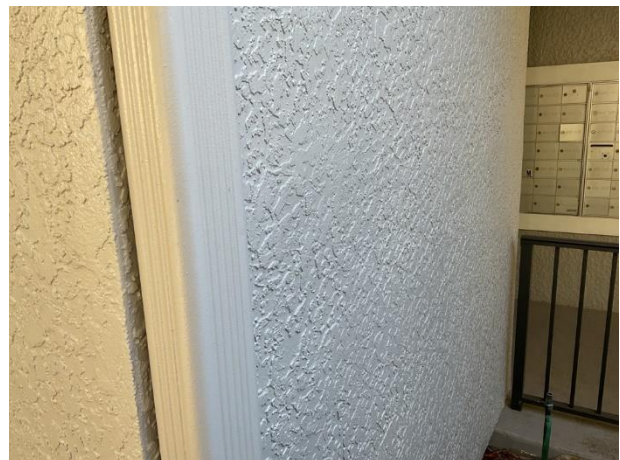
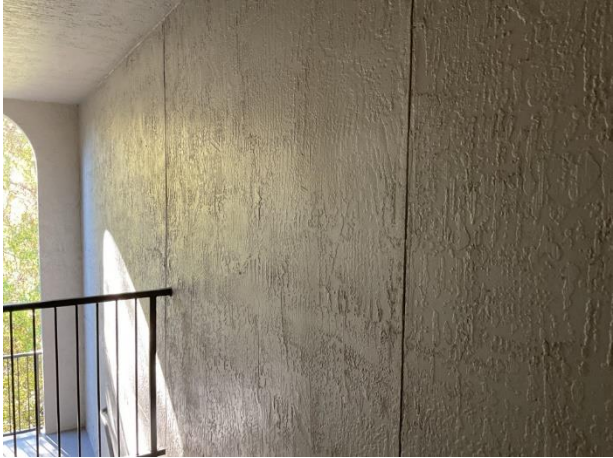
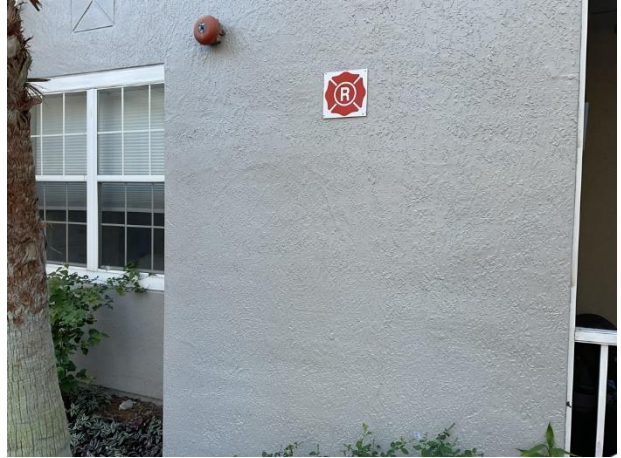
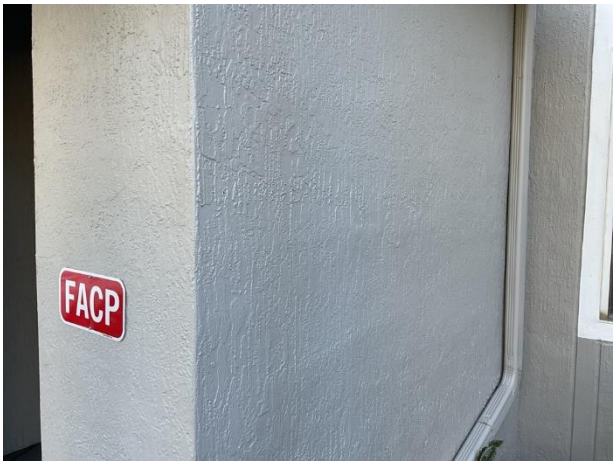
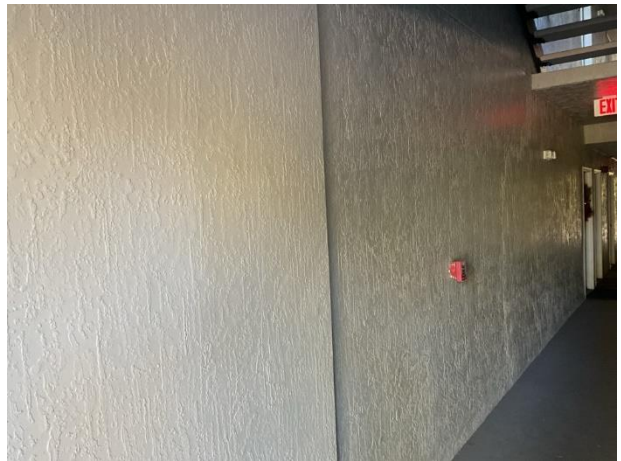
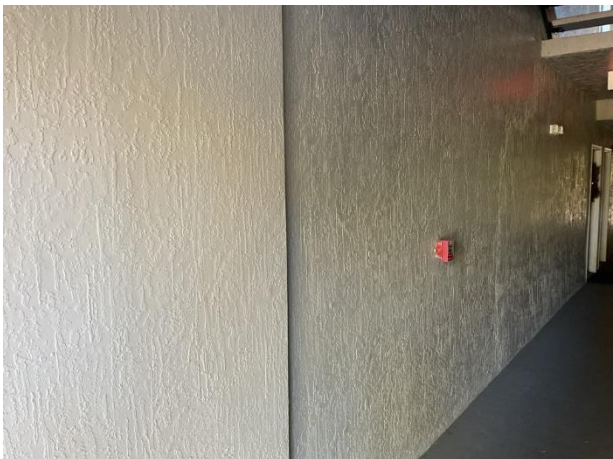
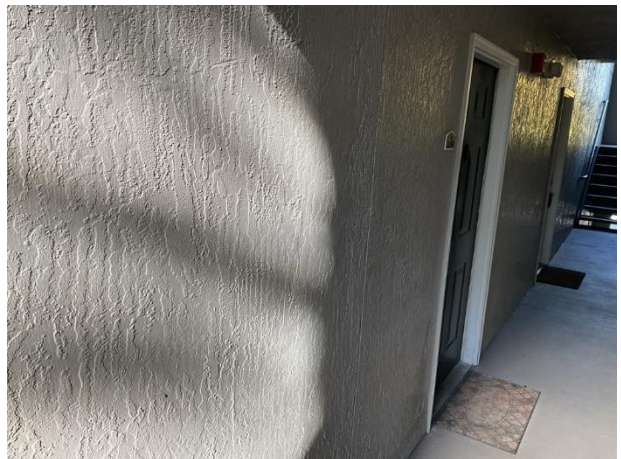
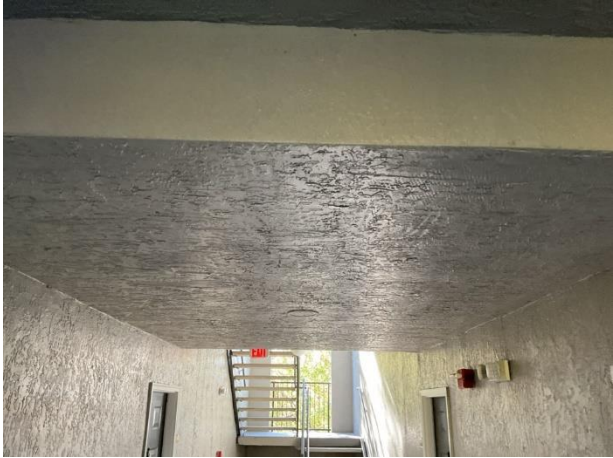
- **Condition:** Good overall with no significant deterioration evident.

Stucco wall finishes

**Stucco wall finishes in breezeway**

**Useful Life:** We recommend inspections, repairs and paint finish applications every five-to seven-years.

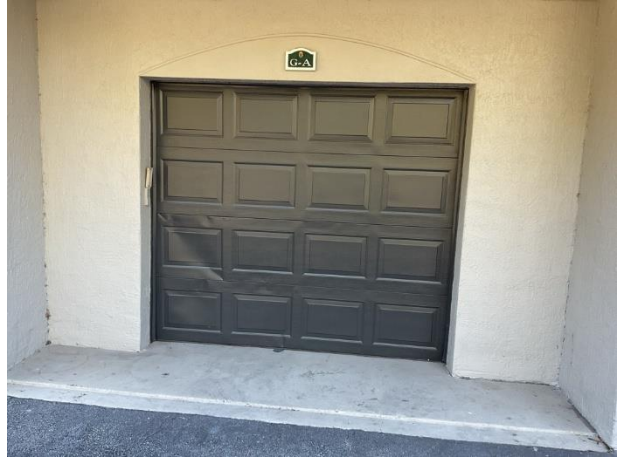
**Garage door paint finishes**

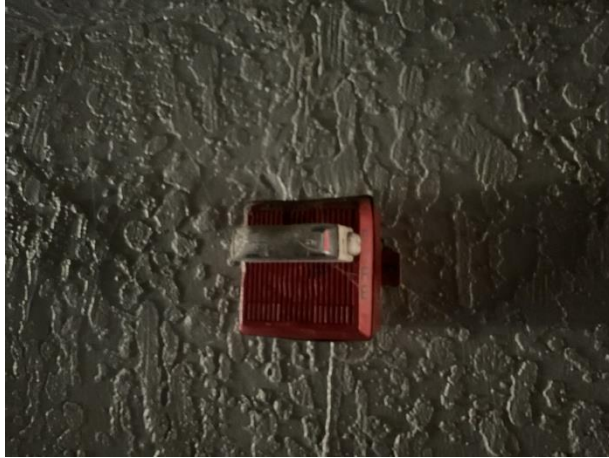
**Conditions:** Reported satisfactory

**Emergency light fixture**

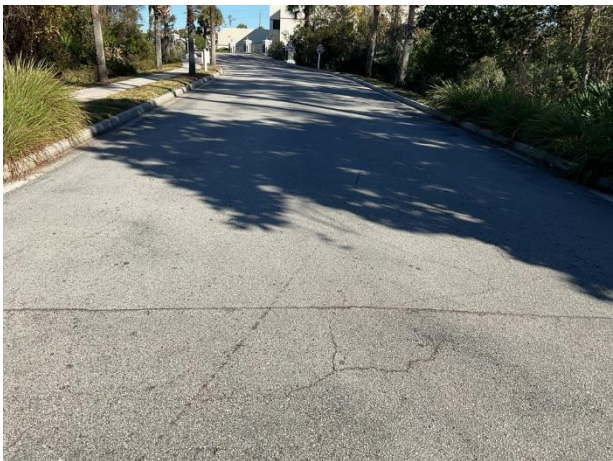
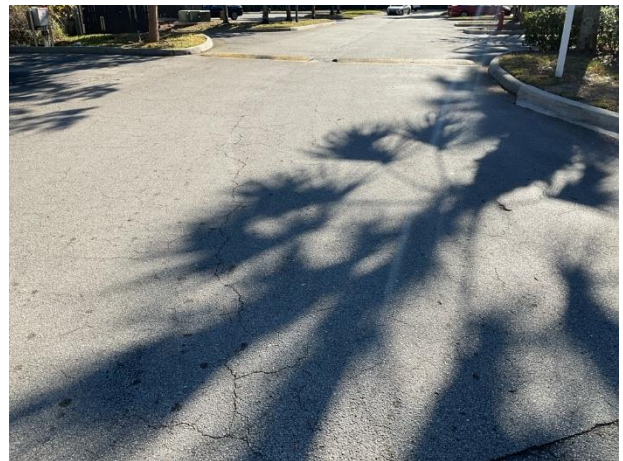
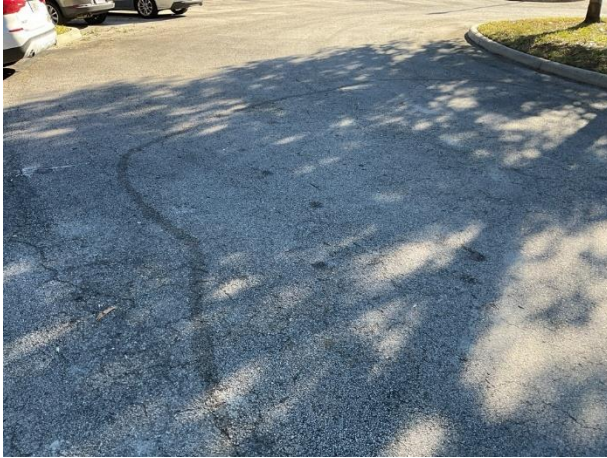
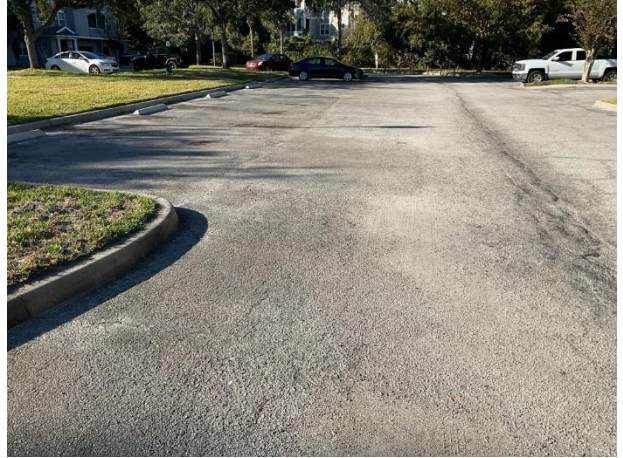
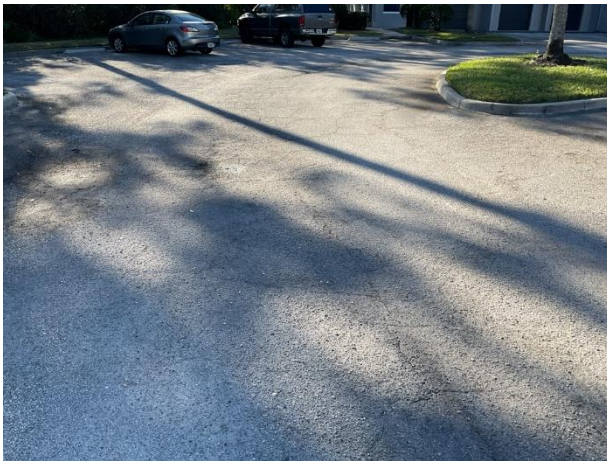
**Condition:** Fair overall with isolated cracks and previous repairs evident.

Pavement overview

application of two or more new lifts of asphalt. We recommend mill and overlayment on asphalt pavement that exhibits normal deterioration and wear. We recommend total replacement of asphalt pavement that exhibits severe deterioration, inadequate drainage, pavement that has been overlaid multiple times in the past or where the configuration makes overlayment not possible. Based on the apparent visual condition and configuration of the asphalt pavement, we recommend the mill and overlay method of repaving at Villa San Marco.

- Annually:
  - Inspect for settlement, large cracks and trip hazards, and ensure proper drainage
  - Repair areas which could cause vehicular damage such as potholes
- As needed:
  - Perform crack repairs and patching

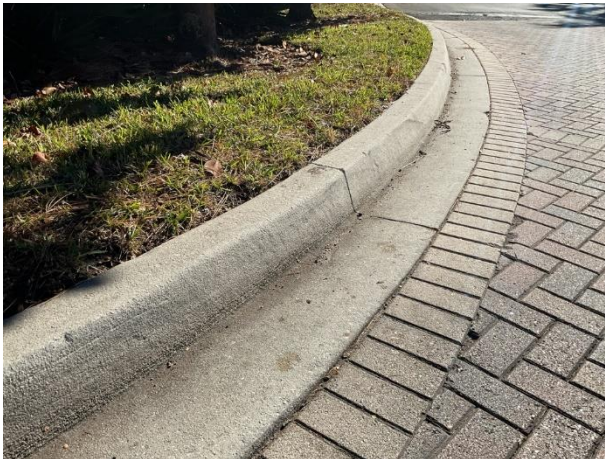
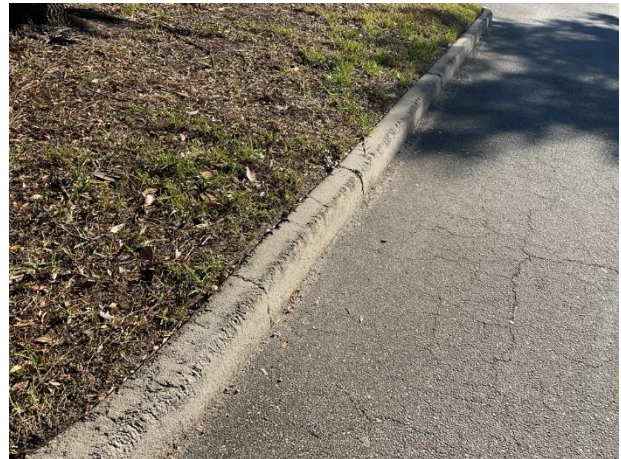
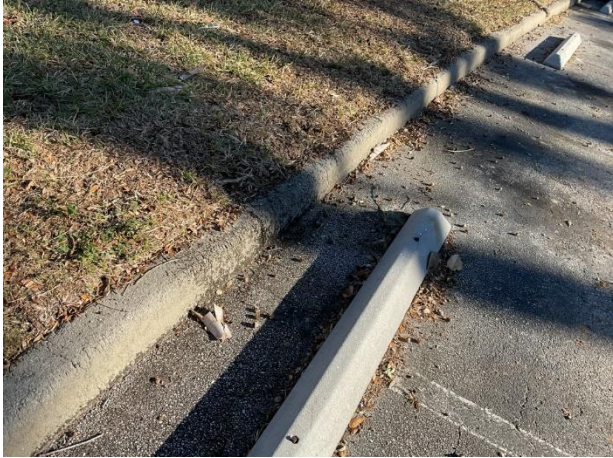
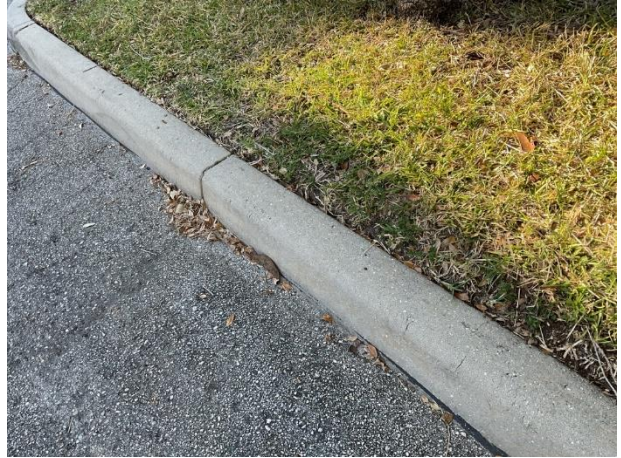
**Condition:** Fair to poor overall with cracks evident.

Concrete curb and gutter

**Expenditure Detail Notes:** Expenditure timing and costs are depicted in the **Reserve Expenditures** table in Section 3. We estimate that up to 1,200 linear feet of curbs and gutters, or thirty percent (30%) of the total, will require replacement during the next 30 years.

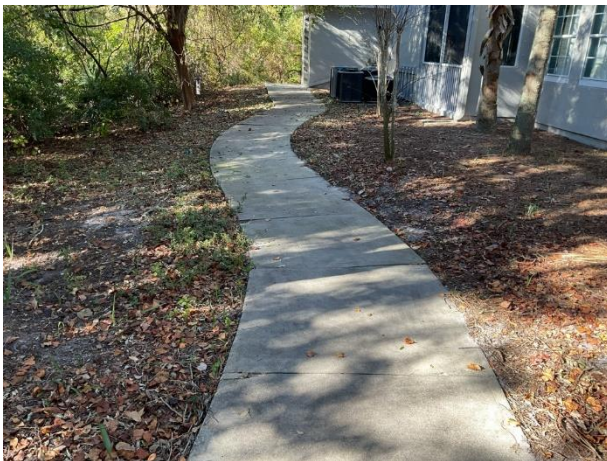
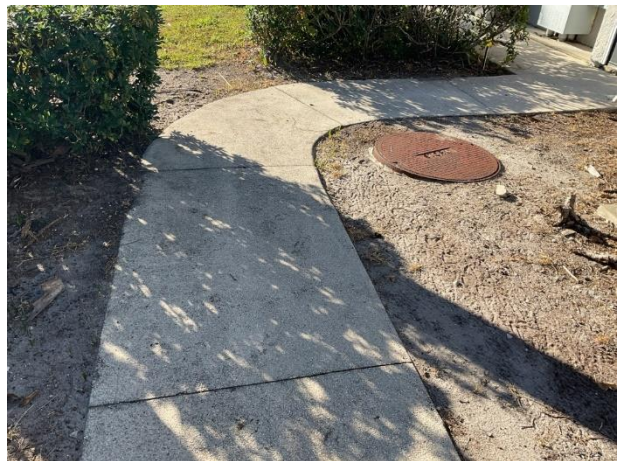
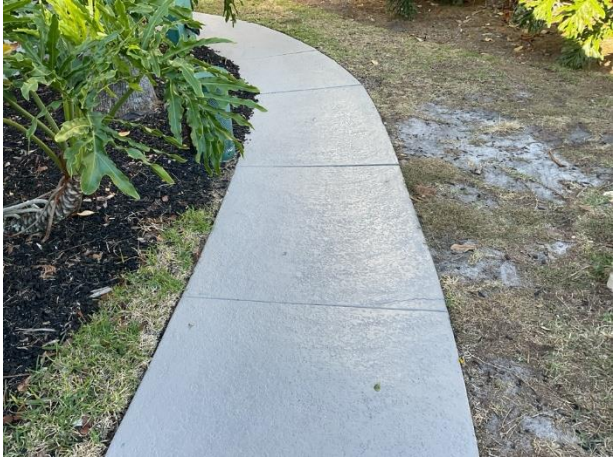
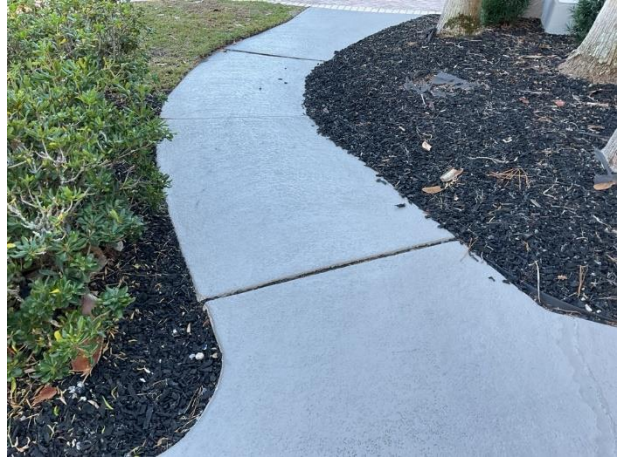
**Condition:** Fair overall with isolated cracks evident.

Concrete sidewalk

**Expenditure Detail Notes:** Expenditure timing and costs are depicted in the **Reserve Expenditures** table in Section 3. We estimate that up to 6,660 square feet of concrete sidewalks, or thirty percent (30%) of the total, will require replacement during the next 30 years.

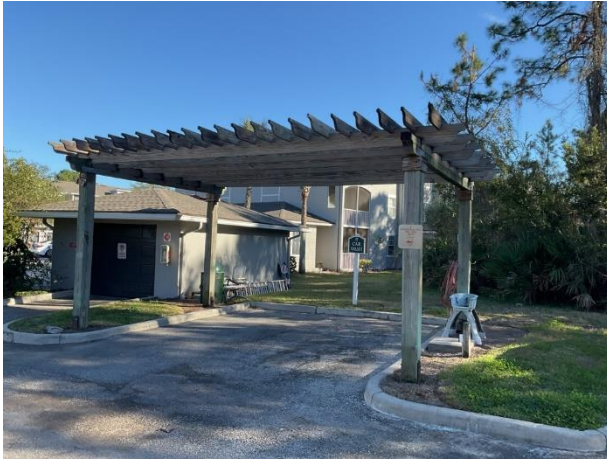
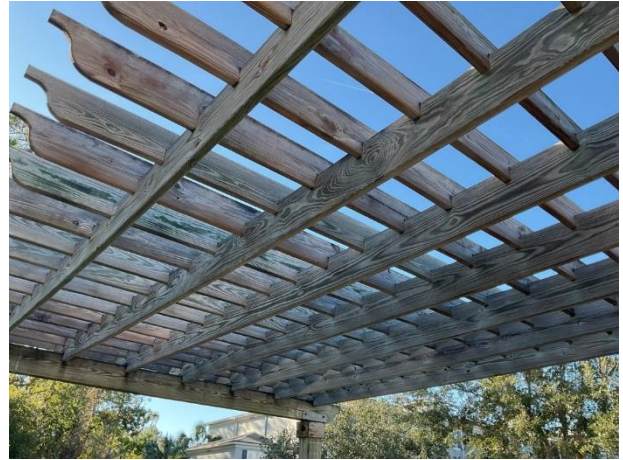
**Condition:** Fair overall with isolated wood deterioration evident

**Pergola**

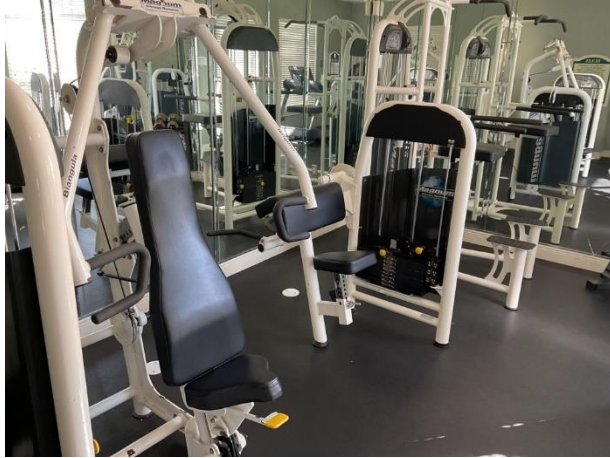
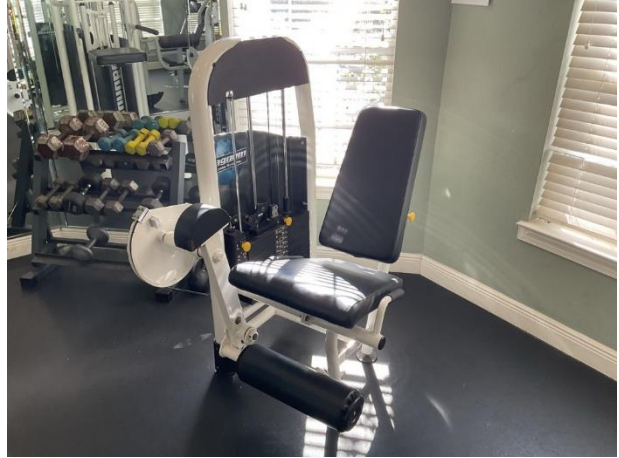
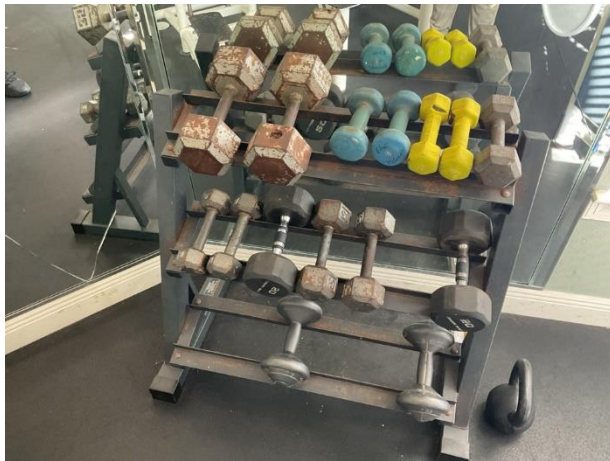
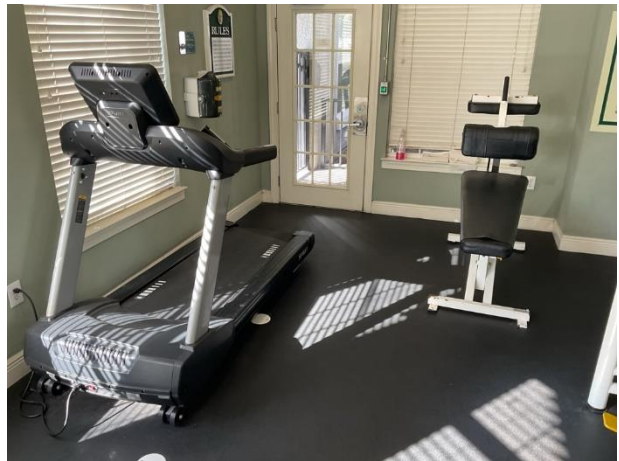
**Conditions:** Fair overall with isolated rust evident.

**Strength training exercise equipment**

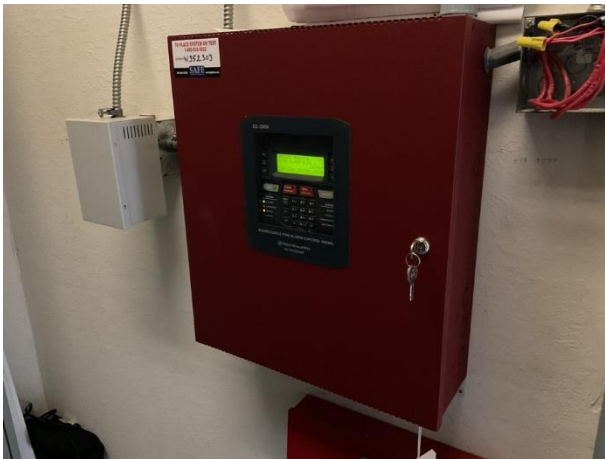
**History:** Control panel and emergency devices were all replaced in 2023

**Conditions:** Reported satisfactory

**Control panel**

**Preventative Maintenance Notes:** We recommend the Association obtain and adhere to the manufacturer's recommended maintenance plan. In accordance with *NFPA 72* (National Fire Alarm and Signaling Code) we also recommend the Association maintain a maintenance contract with a qualified professional. The display panel read 'Trouble in System' at the time of our inspection. The required preventative maintenance may vary in frequency and scope based on the age of the components, operational condition, or changes in technology. We note the following select recommended preventative maintenance activities to maximize the remaining useful life:

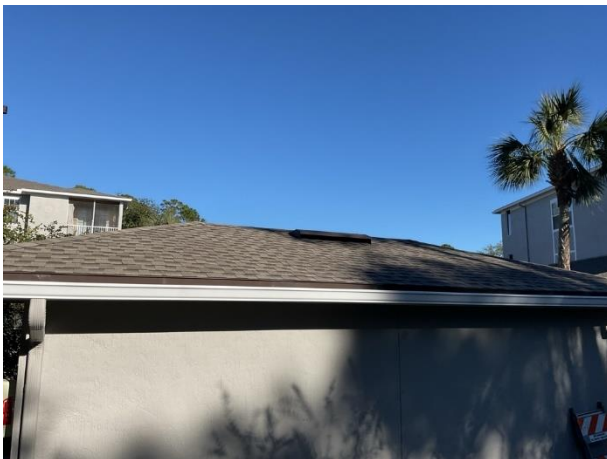
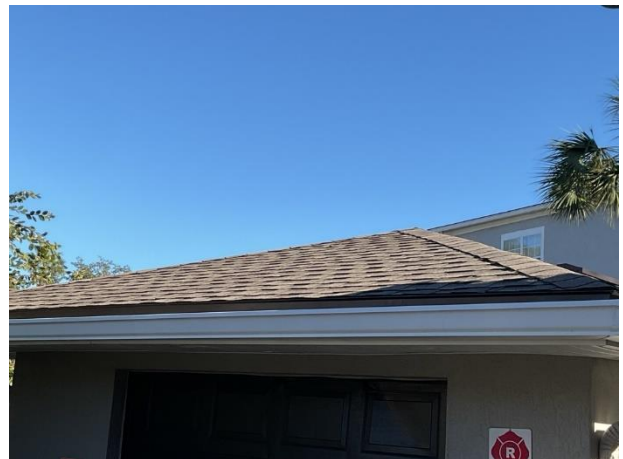
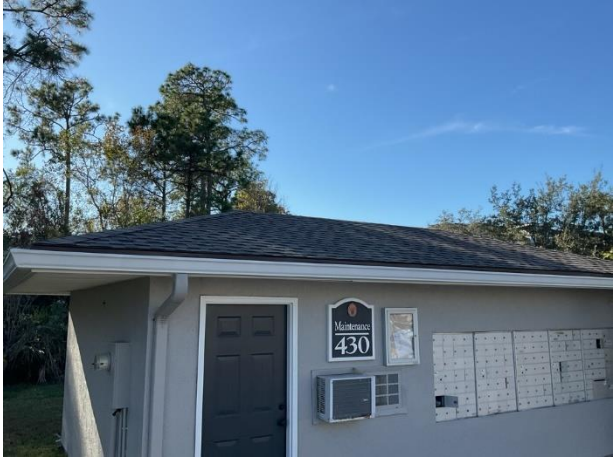
**Condition:** Good

**Maintenance building roof overview**

**Roof overview**

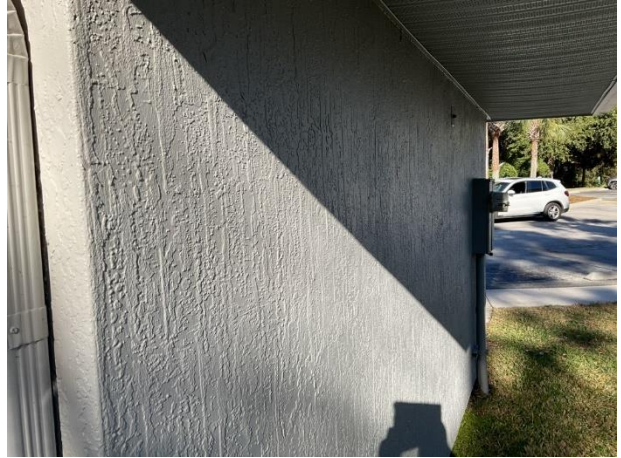
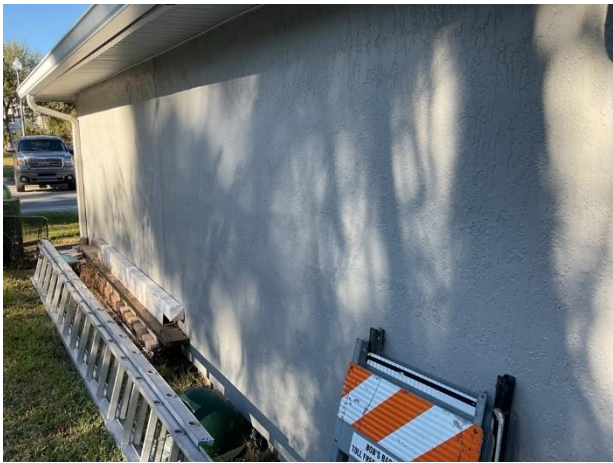
**Stucco wall finishes at maintenance building**

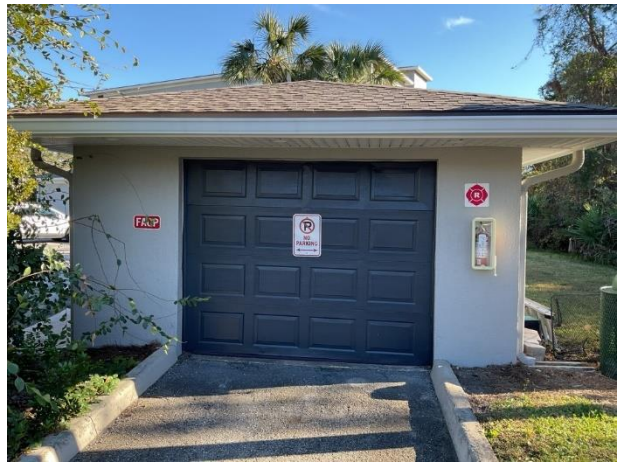
**Garage door**

- Replacement of the entry and garage doors as needed
- Replacement and or capital repairs of the asphalt shingle roof assembly including the gutters and downspouts

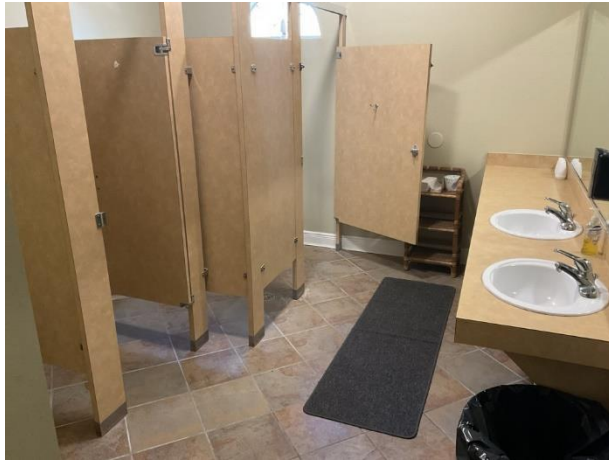
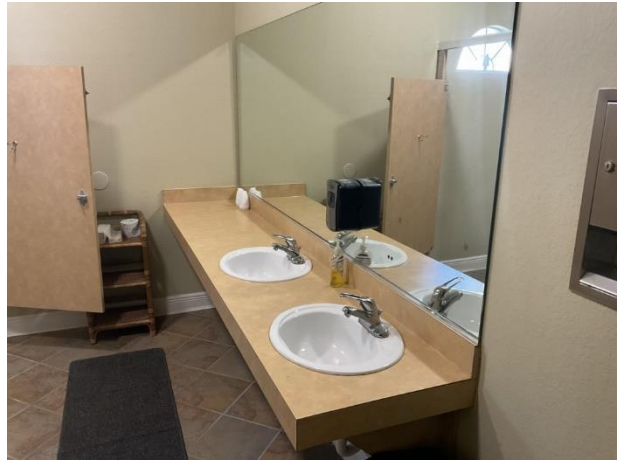
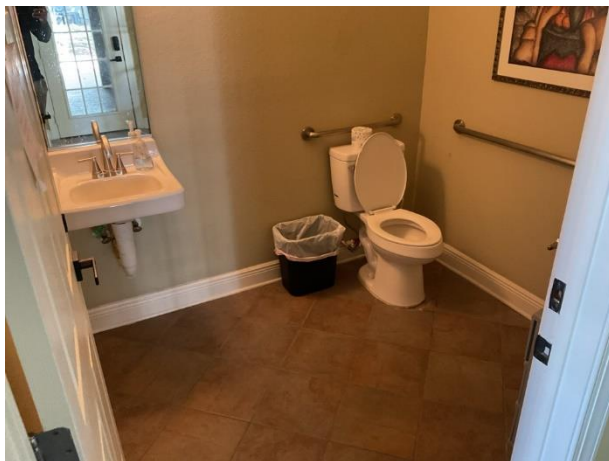
**Condition:** Fair overall with no isolated wall damage and floor previous repairs evident.

Pool rest room overview

Clubhouse rest room

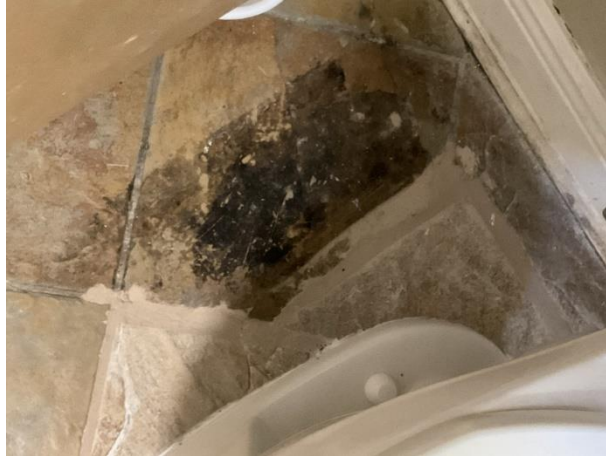
**Pool rest room floor previous repair**

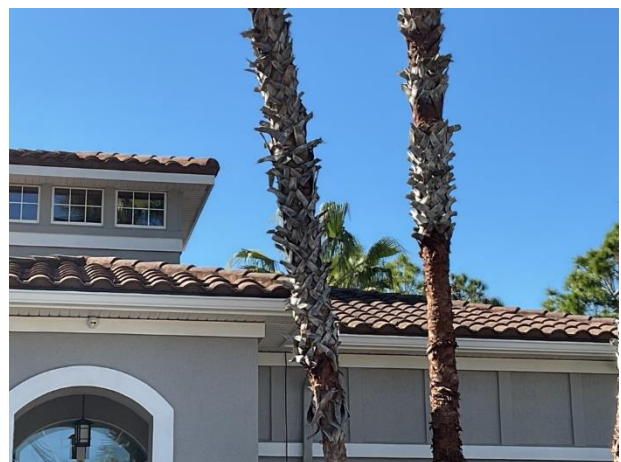
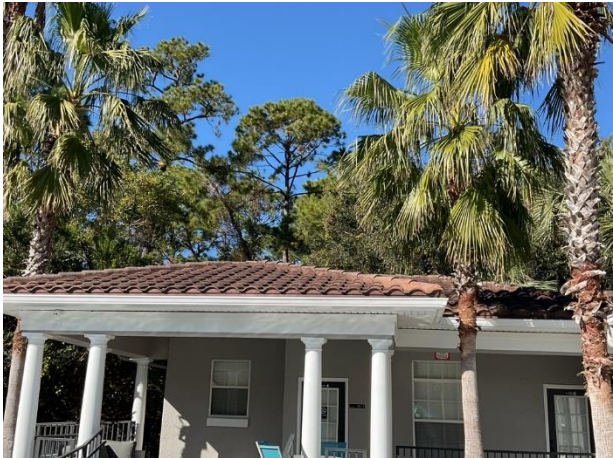
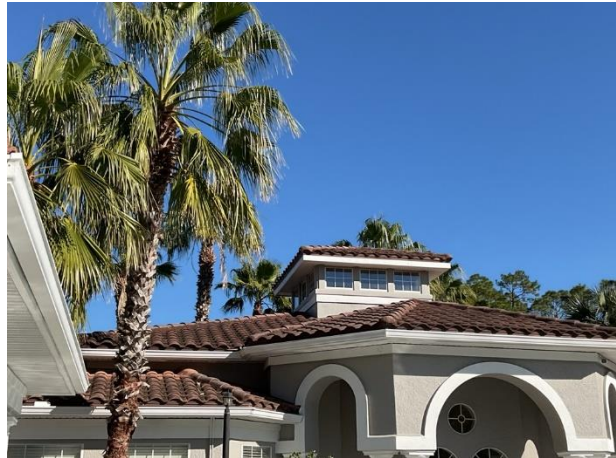
**Condition:** Good to fair overall with isolated weathered tiles evident from our visual inspection from the ground. Management does not report a history of leaks.

**Concrete tile roofs overview**

**Preventative Maintenance Notes:** We recommend the Association maintain a service and inspection contract with a qualified professional and record all documentation of repairs conducted. We note the following select recommended preventative maintenance activities to maximize the remaining useful life:

- Annually:
  - Record any areas of water infiltration, flashing deterioration, damage or loose tiles
  - Implement repairs as needed if issues are reoccurring
  - Ensure proper ventilation and verify vents are clear of debris and not blocked from attic insulation
  - Trim tree branches that are near or in contact with roof
  - Periodic cleaning at areas with organic growth (We do not recommend pressure washing as it may cause further damage to tiles.)

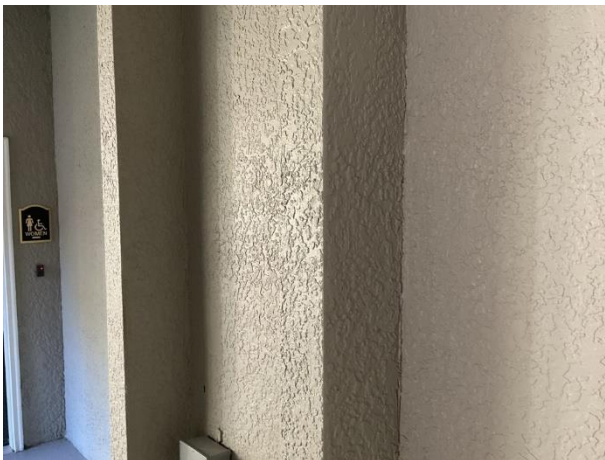
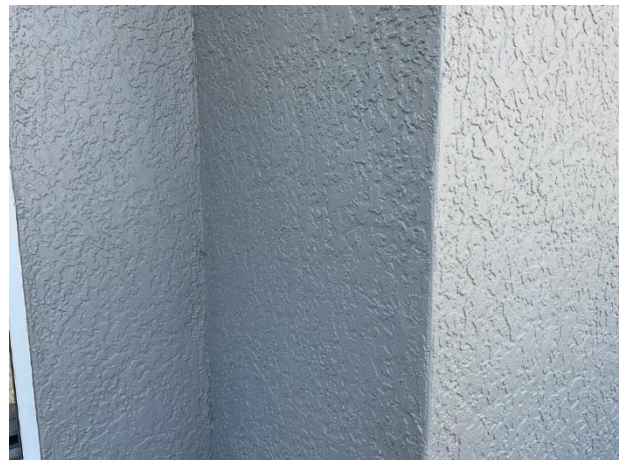
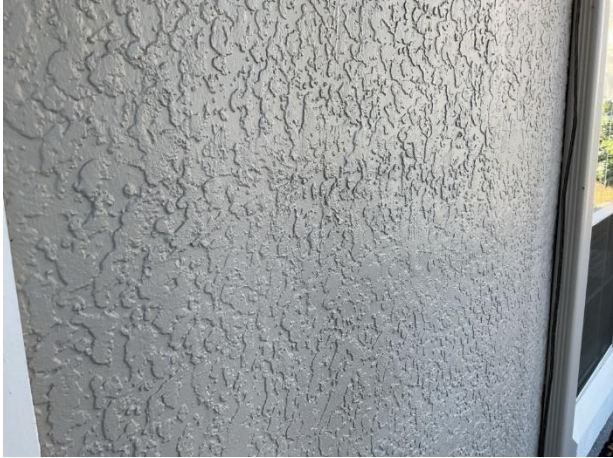
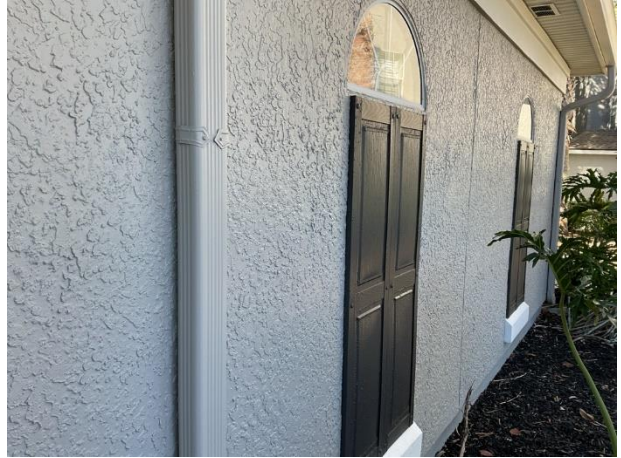
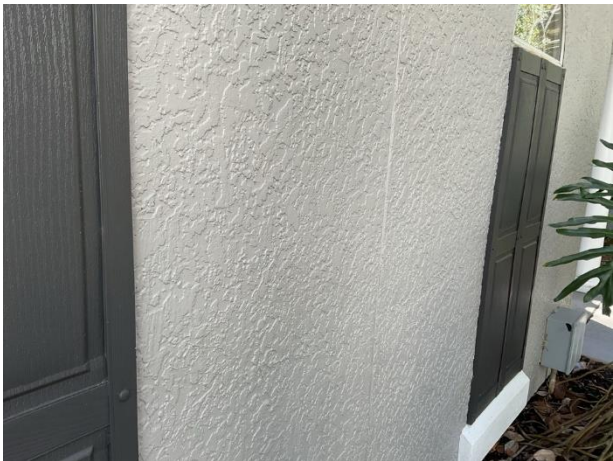
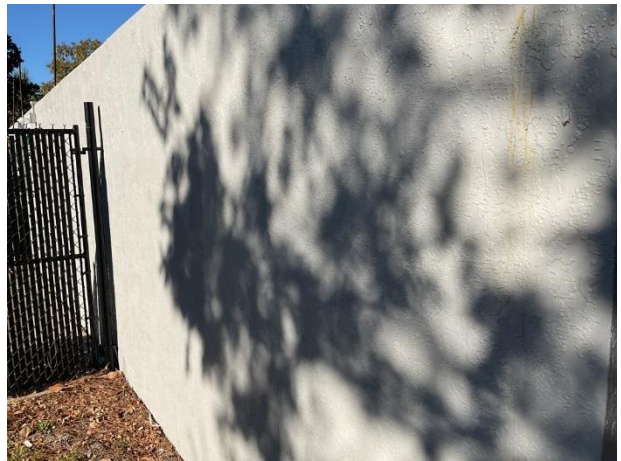
**Condition:** Good overall with no visible deterioration evident.

Stucco wall finishes

**Stucco wall finishes**

**Trash enclosure stucco wall finishes**

**Useful Life:** We recommend inspections, repairs and paint finish applications every five-to seven-years.

- Complete inspection of the stucco
- Crack repairs as needed (Each paint product has the limited ability to cover and seal cracks but we recommend repair of all cracks which exceed the ability of the paint product to bridge.)
- Replacement of up to one percent (1%), of the stucco walls (The exact amount of area in need of replacement will be discretionary based on the actual future conditions and the desired appearance.)
- Replacement of up to thirty-three percent (33%) of the sealants in coordination with each paint finish application.

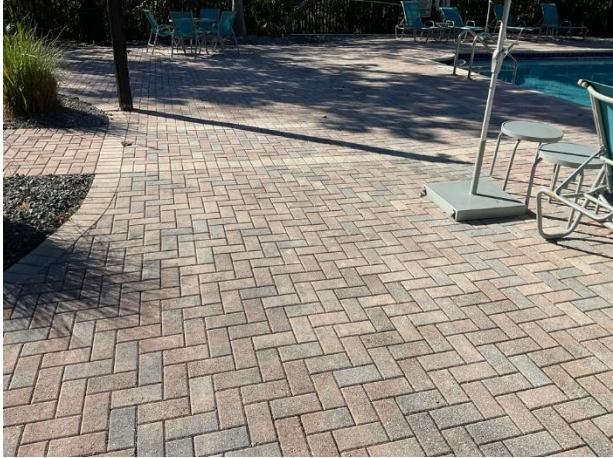
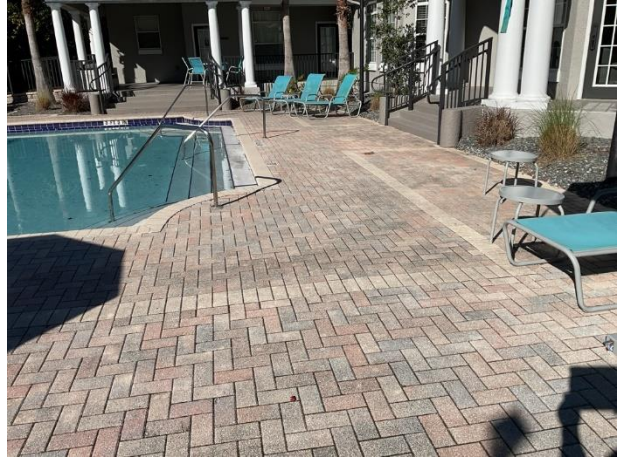
**Condition:** Poor overall with isolated trip hazards evident.

**Paver pool deck overview**

**History:** Original. Management informs us that the community is going to replace the pool deck in 2025

- Annually:
  - Inspect and repair settlement, trip hazards and significant paver spall
  - Reset and/or reseal damaged pavers as necessary
  - Periodically clean and remove overgrown vegetation as needed

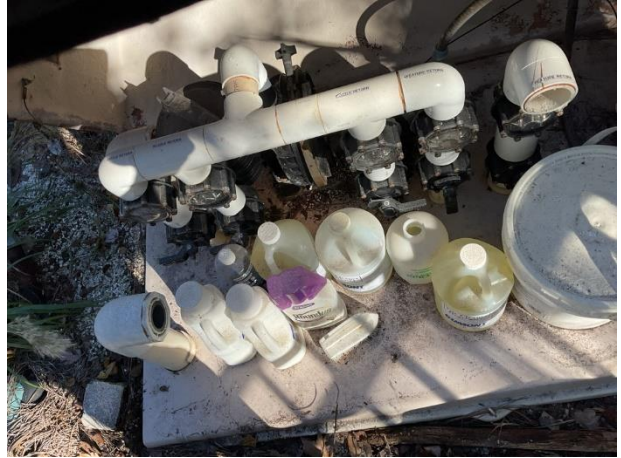
**Pool mechanical equipment**

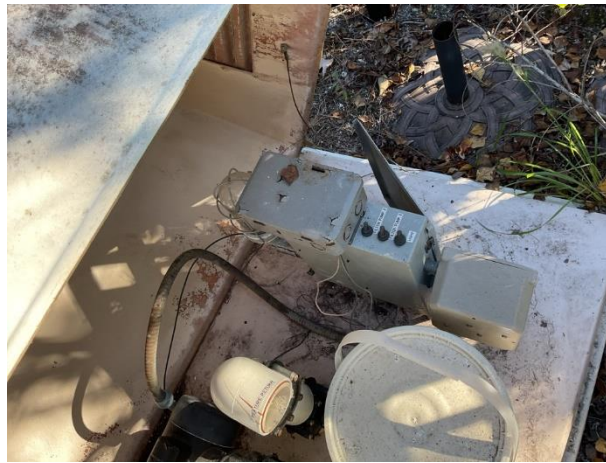
**Pool pumps**

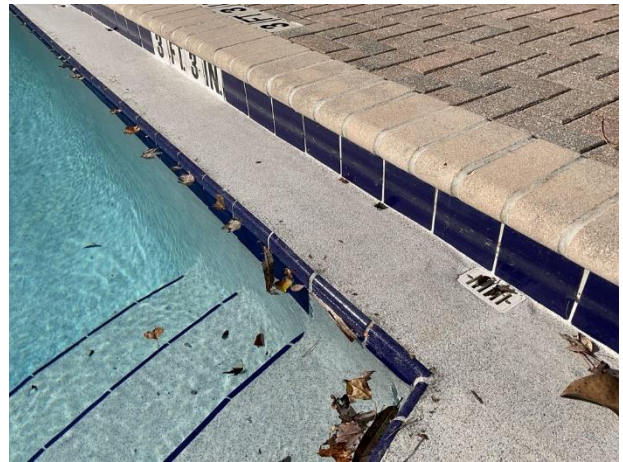
**Condition:** Fair overall with isolated plaster discoloration evident

Pool plaster finish with tile perimeter
